DEPARTMENT OF NATURAL RESOURCES
DIVISION OF OIL, GAS AND MINING

RE: Site Inspection, Georgia-Pacific Corporation, Eagle Canyon Mine, M/015/050, Emery
Couty, Utah

Date of Inspection: May 30, 2003
Time of Inspection: 10:00-10:30 a.m.
Conditions: Mostly clear, 70's
Participants: Paul Baker (DOGM)

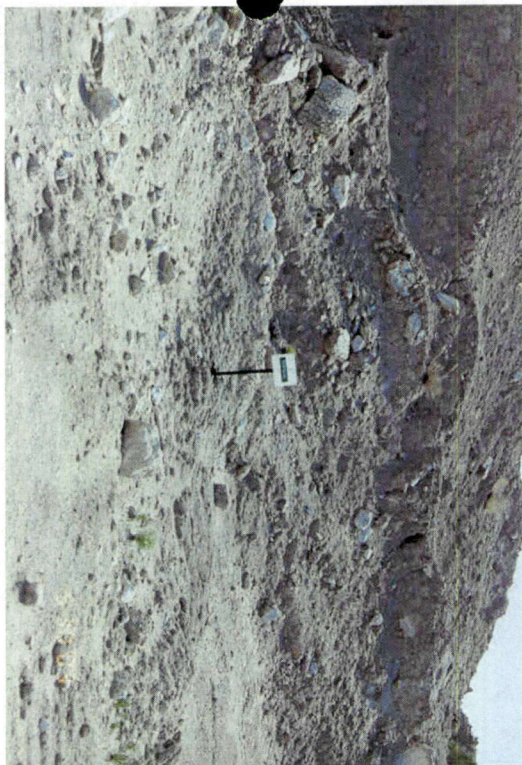
Signs have been placed next to the soil and overburden piles (Photos 1 and 3). This is very helpful for being able to differentiate between the two.

Photo 1. One of the topsoil piles.

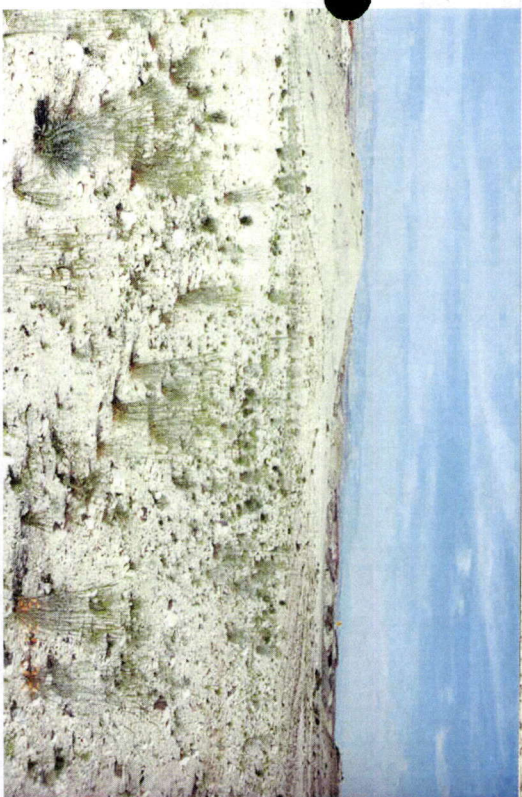
Toward the north end of the mine, there is a vegetated area that looks something like a test plot although I don't believe the plan mentions a test plot (Photos 2, 4, and 5). The soil surface in this area has a coarser texture than the regular topsoil, and it appeared to have a lot of coarse gypsum fragments. Some of the species growing in this area include Russian wild rye (which seems to be doing particularly well), Fremont pepperweed, Indian ricegrass, and Gardner saltbush.

Photo 2. A small revegetated area that looks something like a test plot.

The "test plot" has the best revegetation success of anything I have seen at this mine or other nearby mines. The Division and the operator need to look more closely at what revegetation methods were used in this area and particularly need to determine, as well as possible, what soil treatments were used.

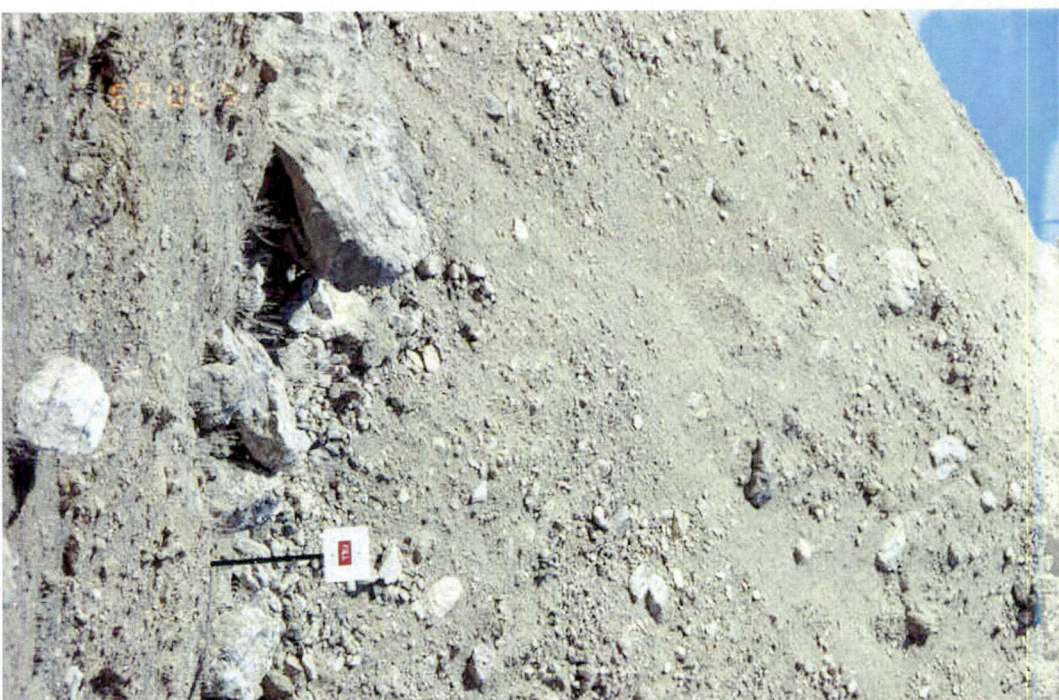
Photo 3. One of the piles of fill/overburden.

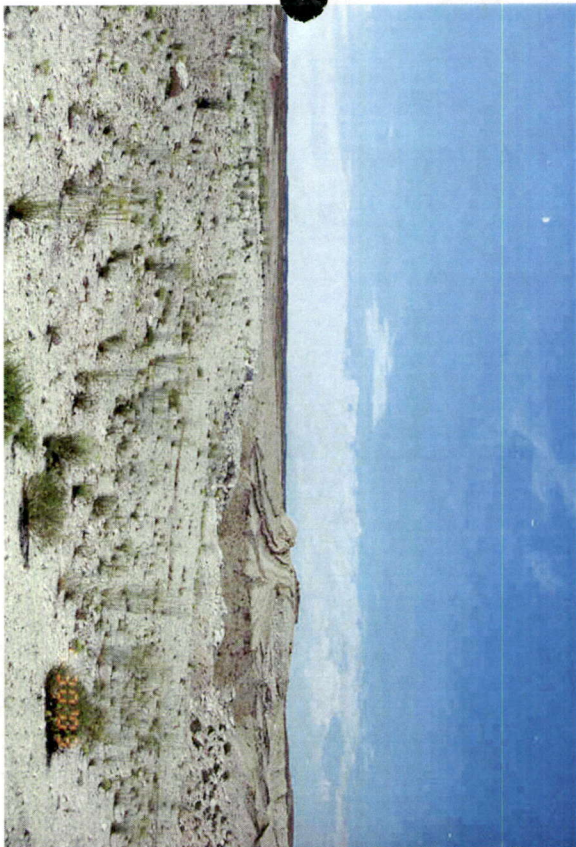
In the north central portion of the disturbed area, there is a soil pile which, it appears, has been partly graded into one of the mine pits (Photo 4). This pile is marked as a soil pile.

Photo 4. Another view of the area that looks like a test plot. It appears the soil pile in the right center of this photo is being graded into one of the pits.

The operator needs to protect the soil resources and not use soil as fill.

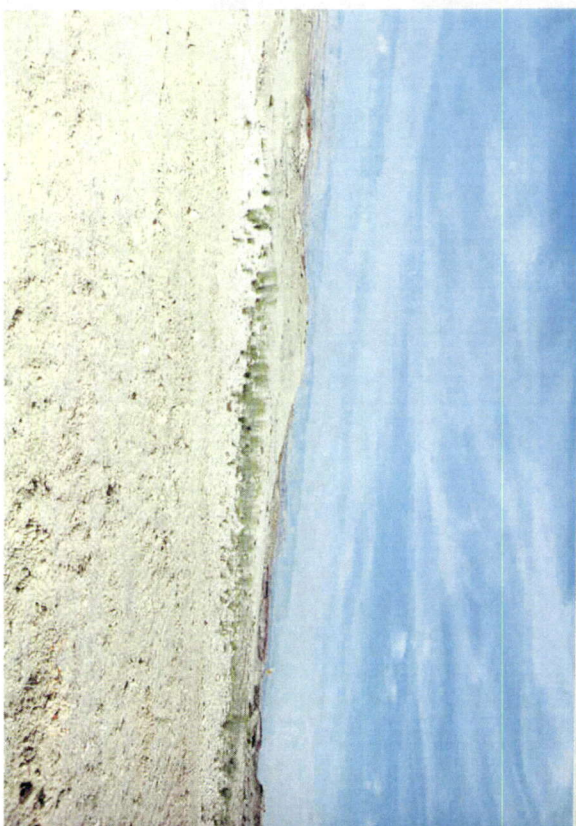
Photo 5. Another view of the "test plot."
